## A Review of the Former Marble Quarry Landfill Site

*Hughes Environmental Consulting Services*  
*157 Strong Ave., Syracuse, NY 13210*

**April 25, 2016**

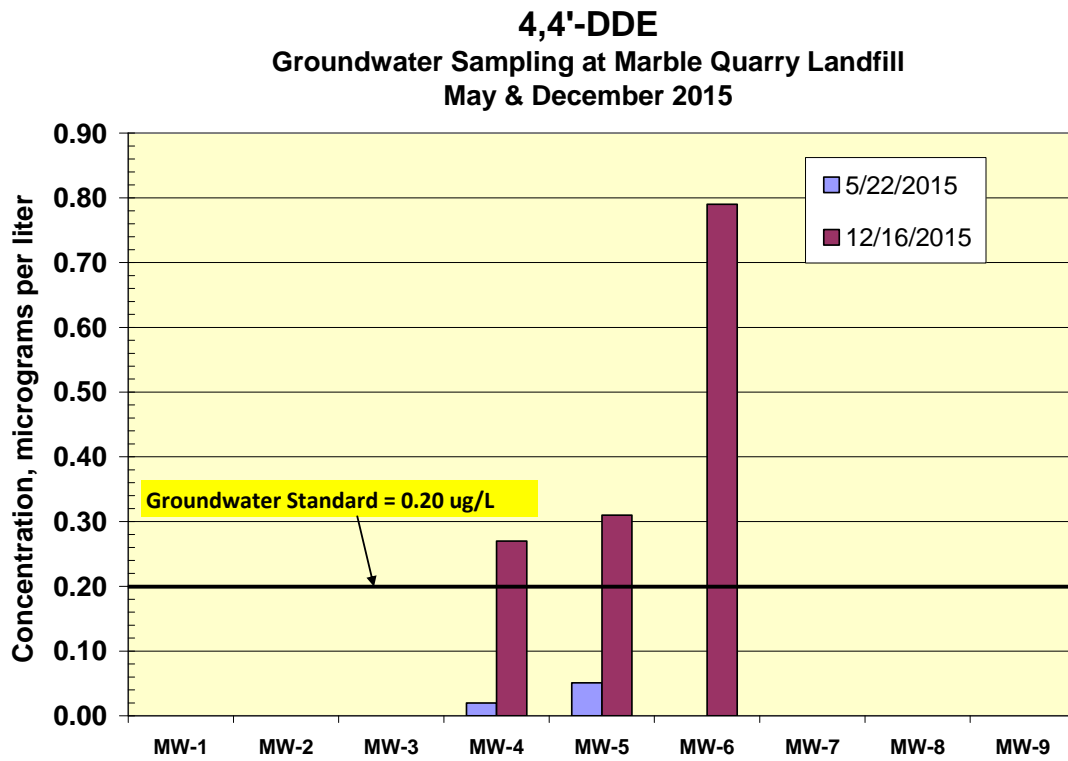
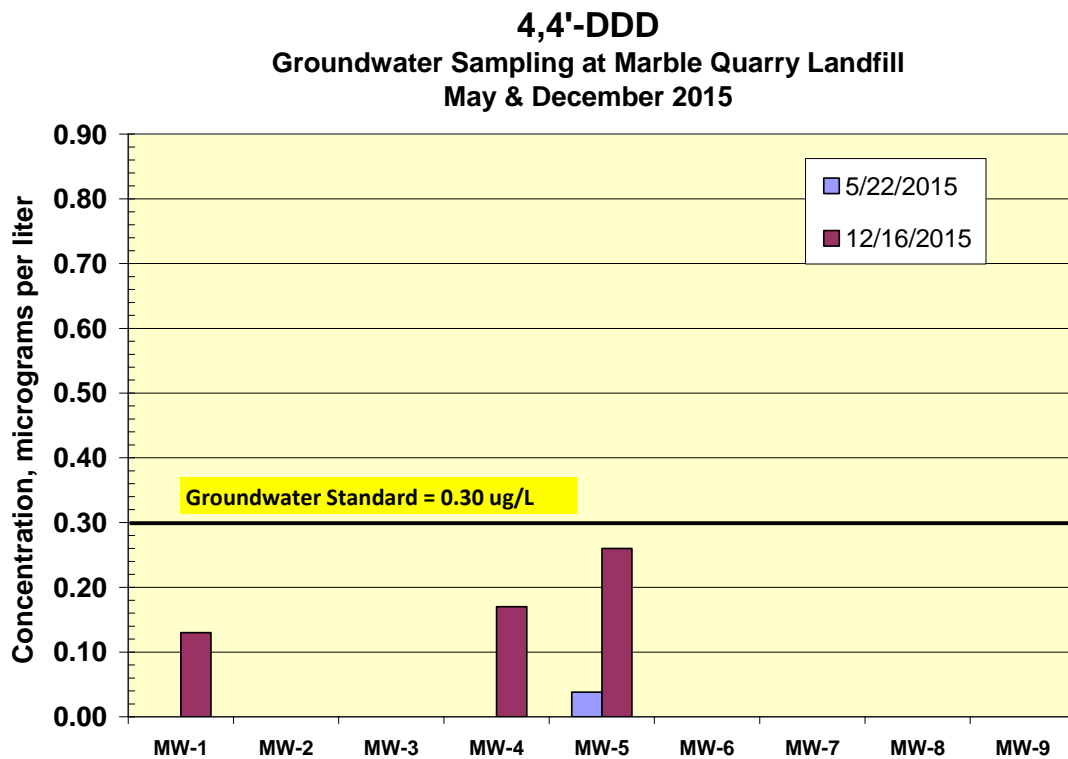
Figure 2A. Groundwater results for 4,4'-DDD and 4,4'-DDE compared to NYS ambient water standards.

- Two breakdown products of the pesticide DDT were found three wells in May 2015, and four wells in December 2015. As shown in Figure 2A, all detected concentrations were far above the ambient groundwater standard of 0.01 µg/L.

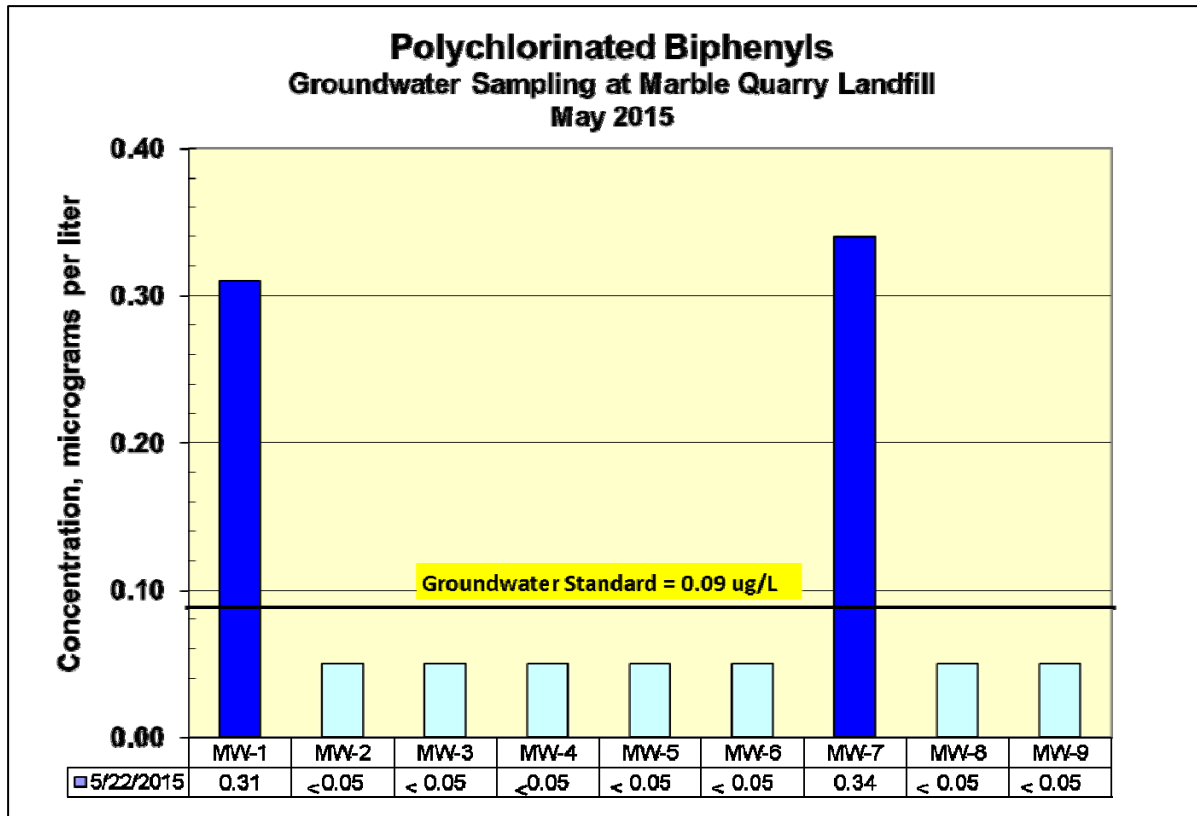
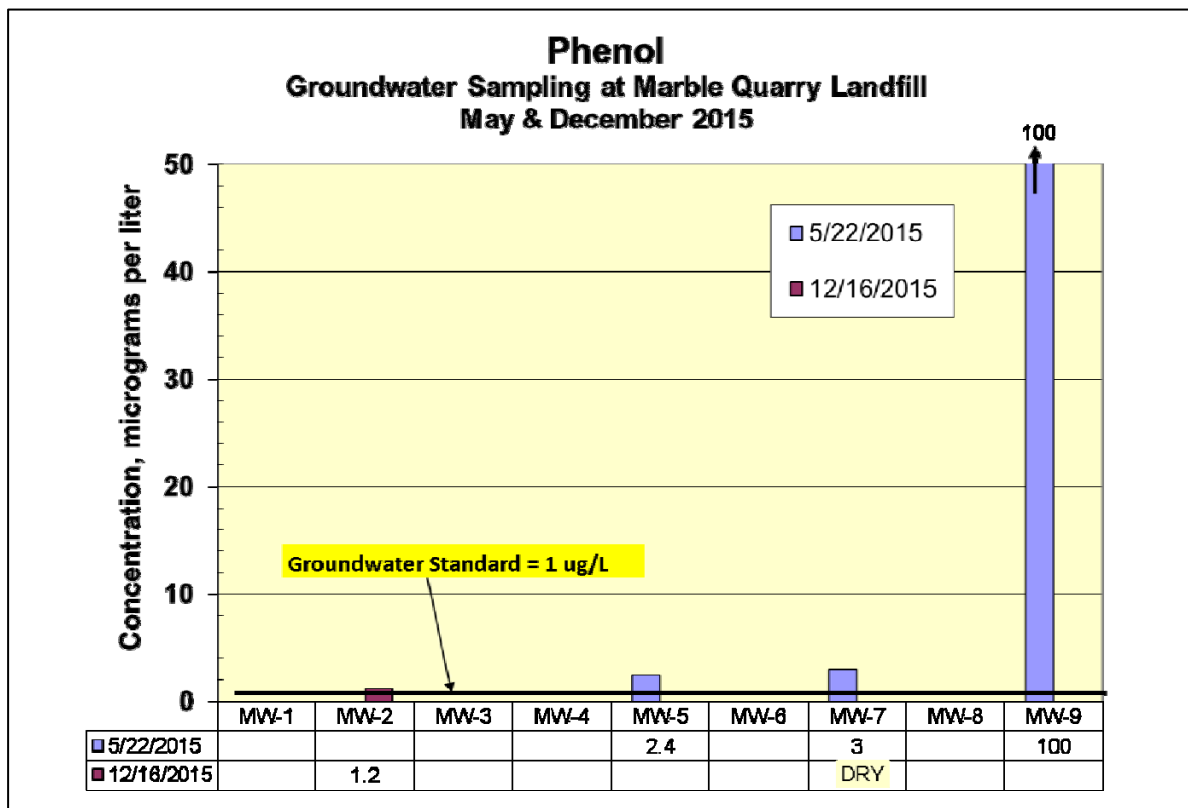
Figure 2B. Groundwater results for PCBs and phenol compared to NYS ambient water standards.

PCBs were found above groundwater standards in samples from two wells in May 2015: MW-1 and MW-7 (see Figure 2B.). Both samples were quantified as Aroclor 1260, which indicates electrical transformer oil as the probable source. No PCBs were reported in the December samples, but high laboratory reporting limits (~0.5 µg/L) may have made it impossible to find PCBs.

The compound phenol, which has an ambient groundwater standard of 1 µg/L, was found above this standard in several groundwater samples in May and December 2015. (See Figure 2B.) Concentrations in May ranged as high 100 µg/L (in MW-9), but only 1.2 µg/L in December. The reason for the wide discrepancy in results is unknown.

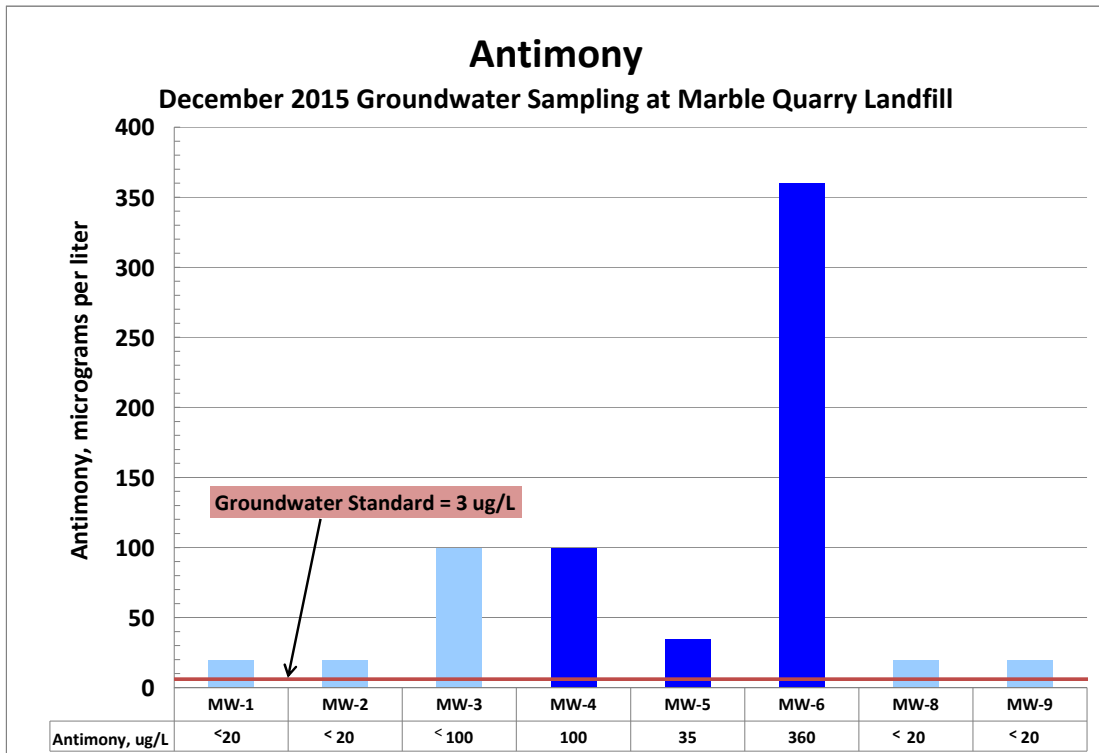
**Figure 2C. Groundwater results for antimony and arsenic compared to NYS ambient water standards.**

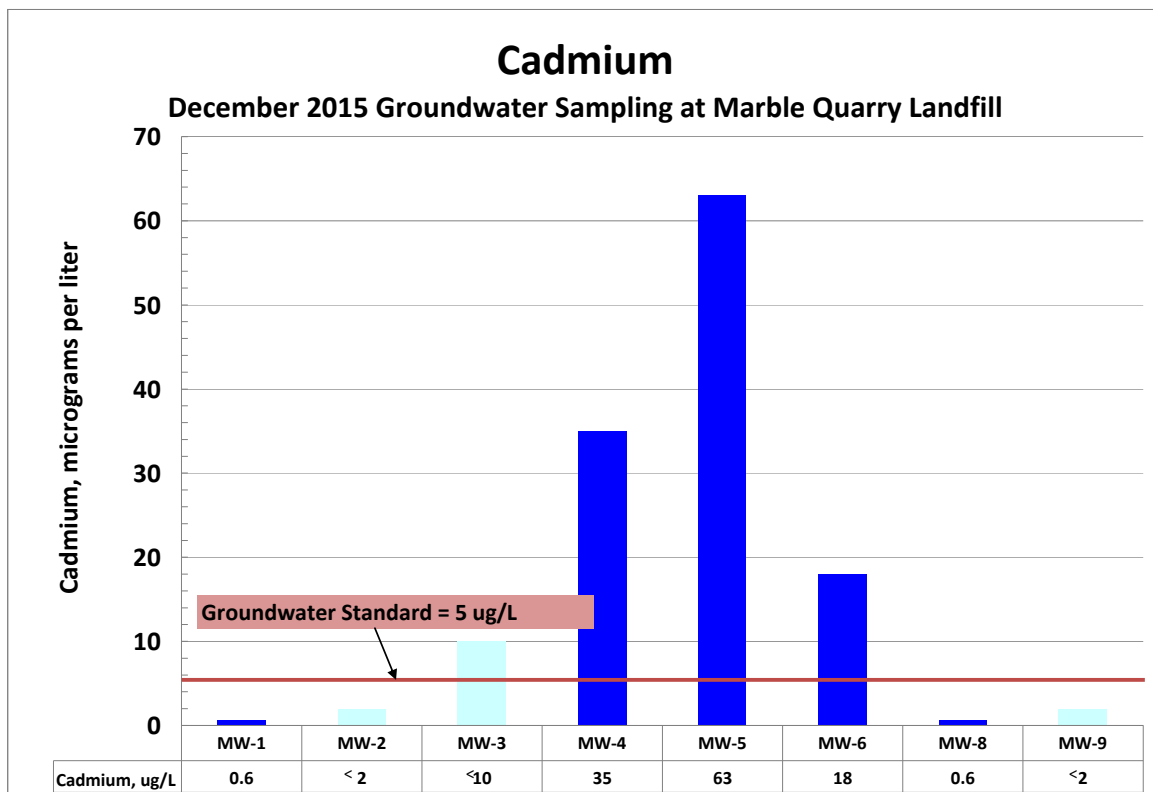
**Figure 2D. Groundwater results for barium and cadmium compared to NYS ambient water standards.**

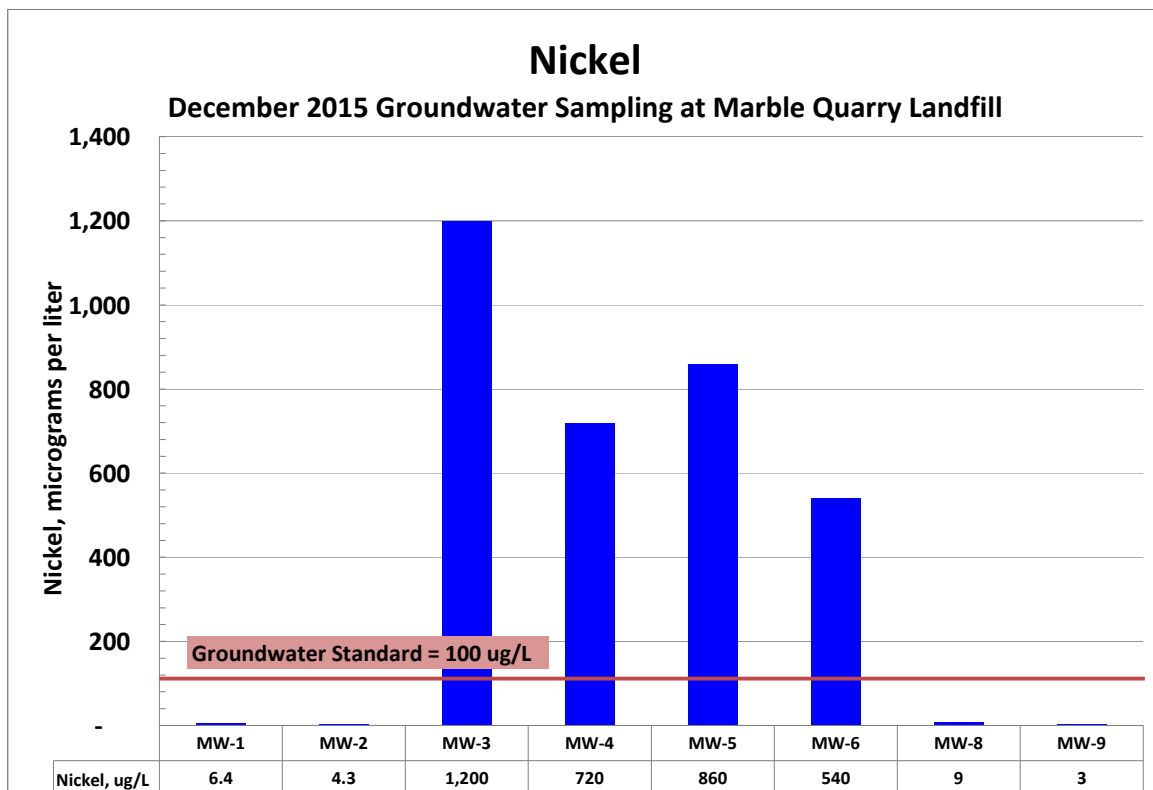
**Figure 2F. Groundwater results for mercury and nickel compared to NYS ambient water standards.**

- Copper exceeded the standard of 200 µg/L in MW-3, -4, -5, and -6 (up to 28 times)
- Mercury exceeded the standard of 0.7 µg/L in MW-3, -4, -5, and -6 (up to 23 times)

- Nickel exceeded the standard of 100 µg/L in MW-3, -4, -5, and -6 (up to 12 times)
- Lead concentrations were extremely high in MW-3, -4, -5, and -6, ranging from 5,500 to 34,500 µg/L; groundwater in these four wells exceeded the standard of 25 µg/L by factors of 220 to 1,380 times. MW-1 also exceeded the standard, but only by a factor of about two.

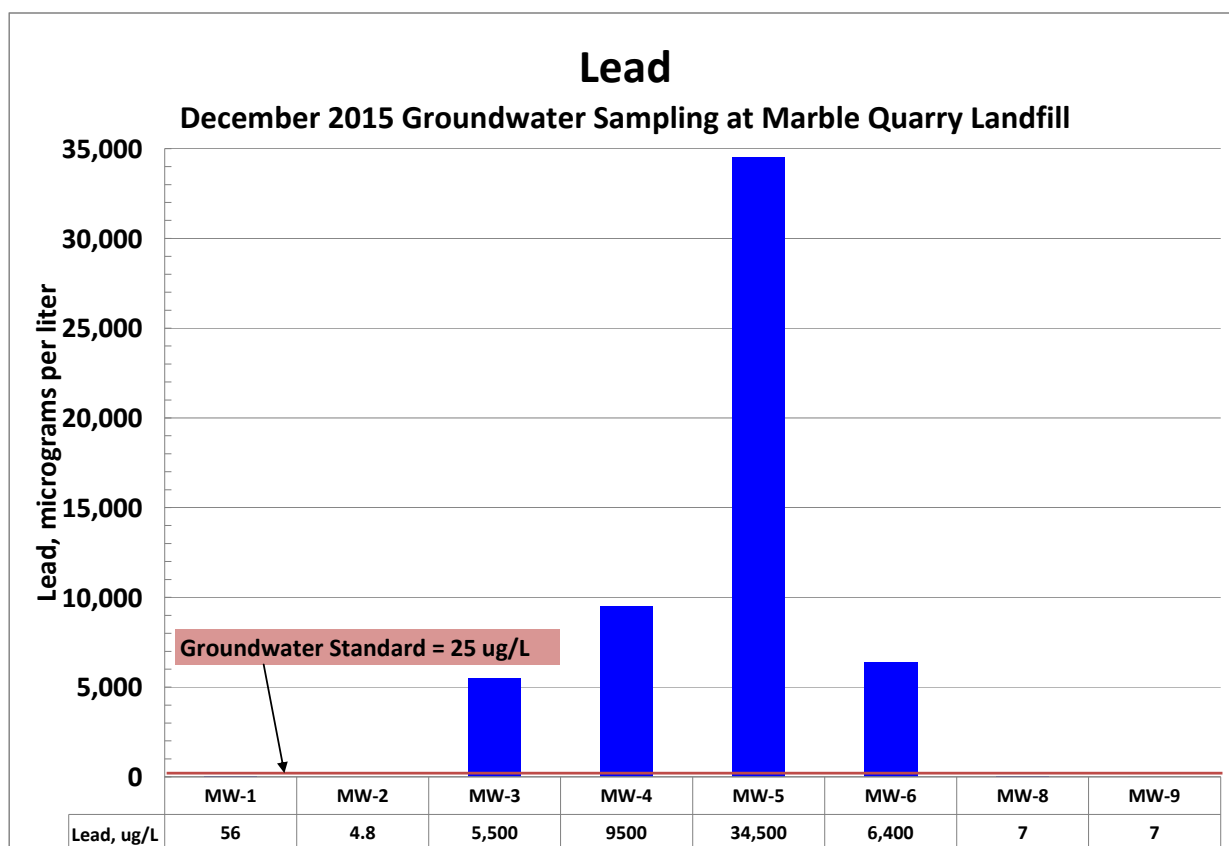
**Figure 2G. Groundwater results for lead compared to NYS ambient water standards**

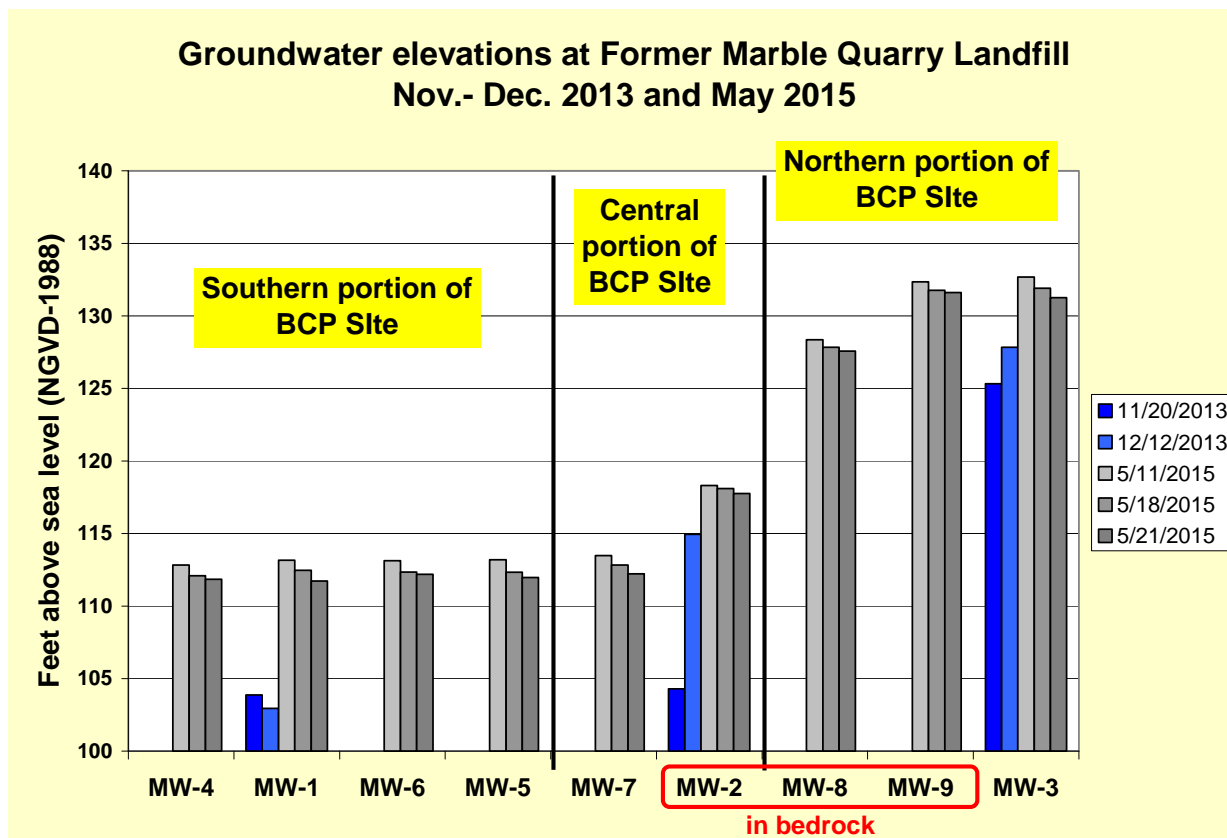
**Figure 3. A comparison of groundwater elevations observed at the BCP Site, 2013 - 2015.** Monitoring wells are ordered left-to-right, approximately south to north, with MW-4 at the southern edge, and MW-3 near the north end of the Site.

Overall, there is no consistency among the three bedrock wells, nor among the six wells completed in the fill material. Clearly, the Applicant has not collected sufficient groundwater information specific to each aquifer to enable construction of groundwater flow maps.
