# Marbledale Road BCP Site: Review of Soil Vapors

**Donald J. Hughes, P.E., Ph.D.**

*Hughes Environmental Consulting  
Syracuse, NY*

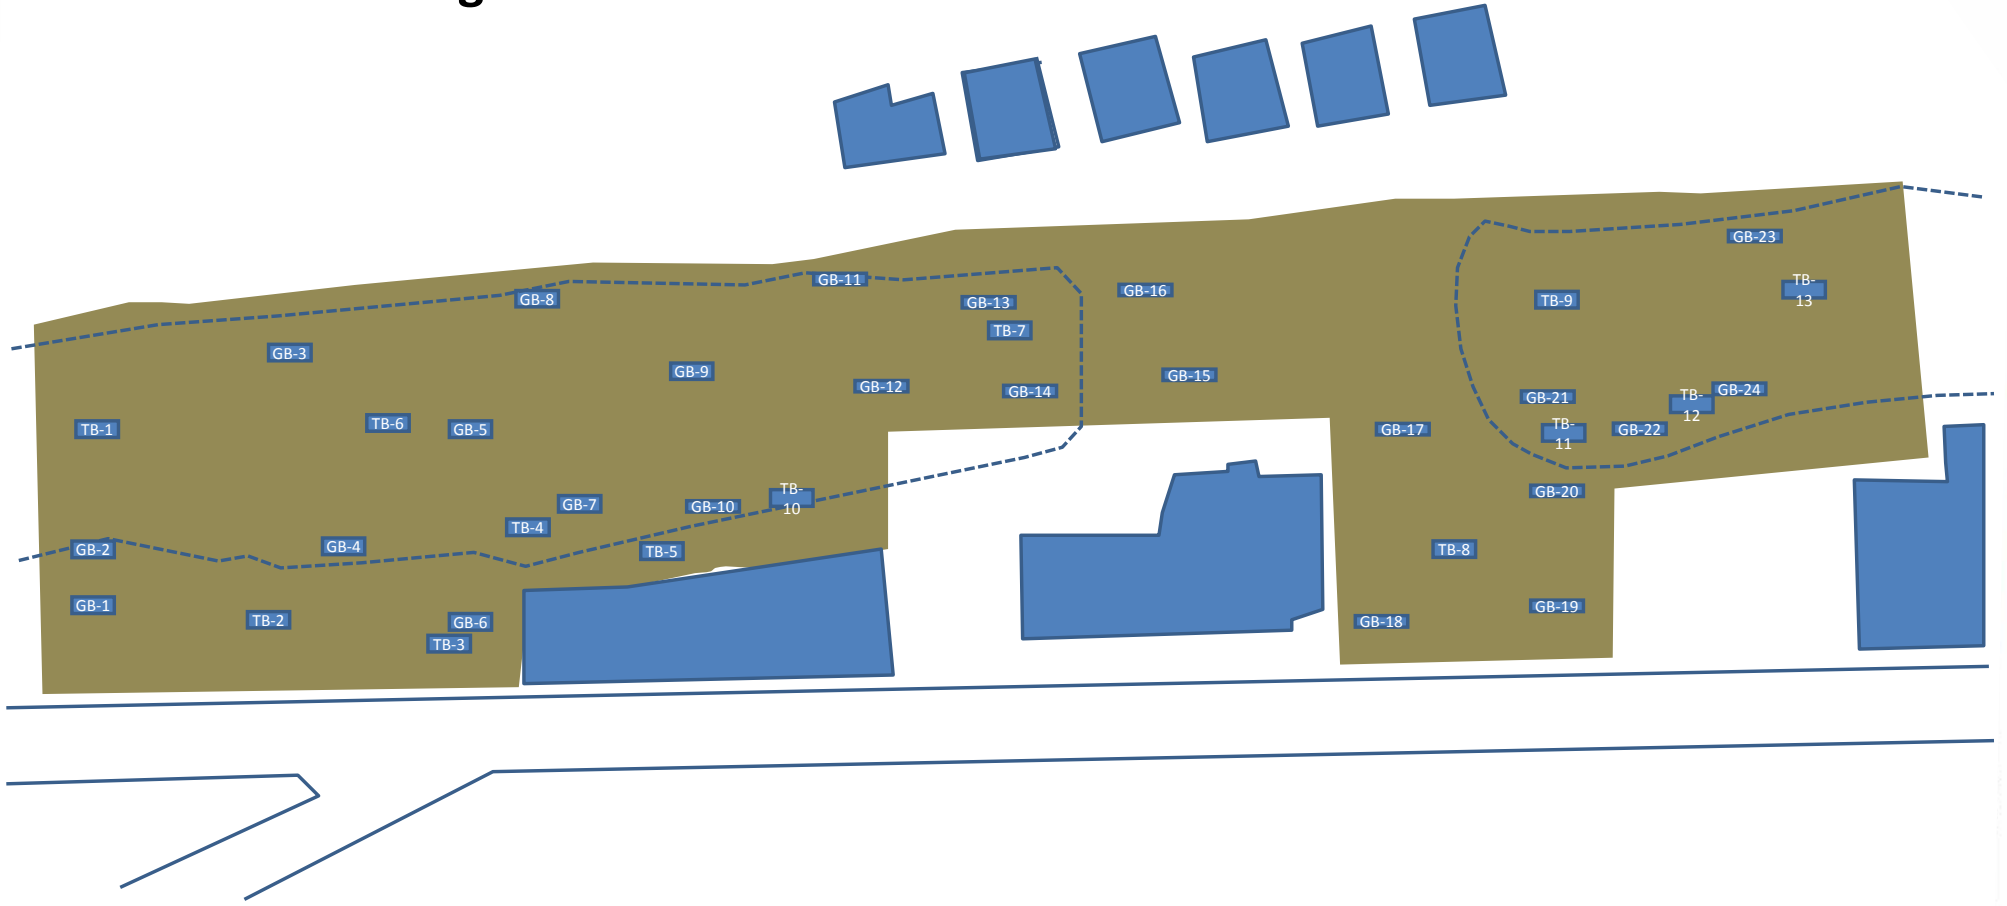
# Soil Borings Collected in 2013 and 2015

Adapted from HydroEnvironmental Solutions (2016) Remedial Investigation Report, Figure 3.

Note that locations of soil borings installed in 2013 are approximate.

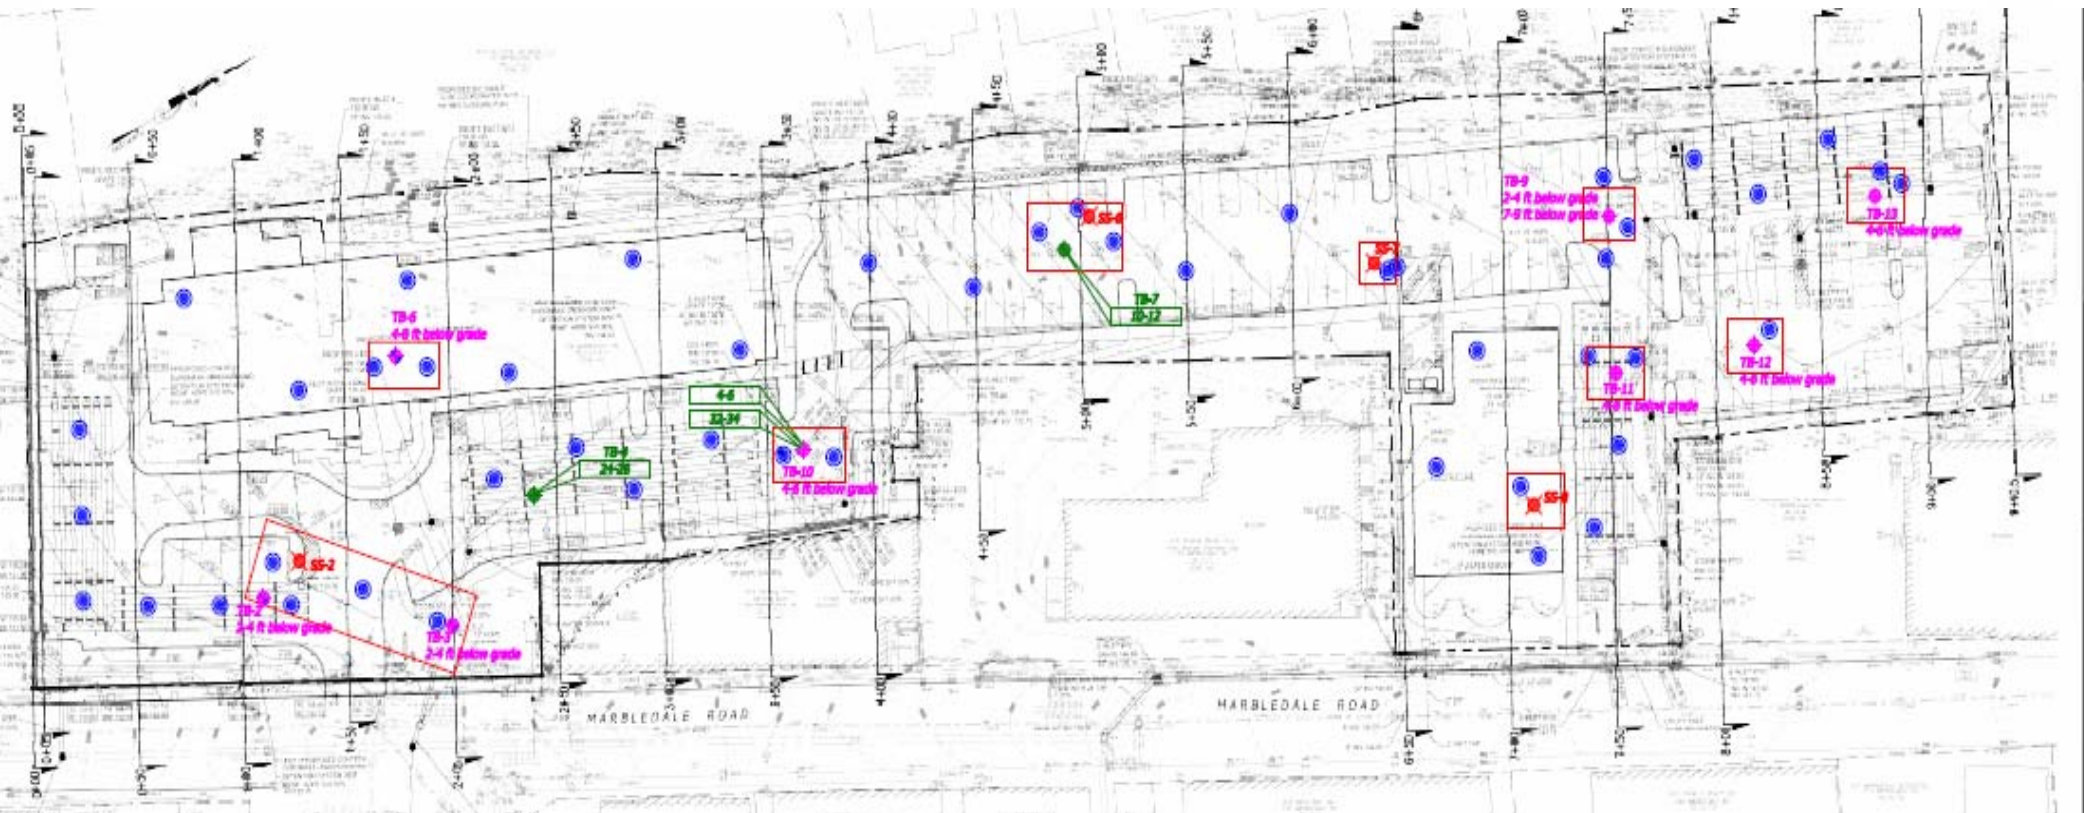
## New soil sampling points

Adapted from HydroEnvironmental Solutions (2016) Remedial Investigation Report, Figure 3.

Note that locations of soil borings installed in 2013 are approximate.

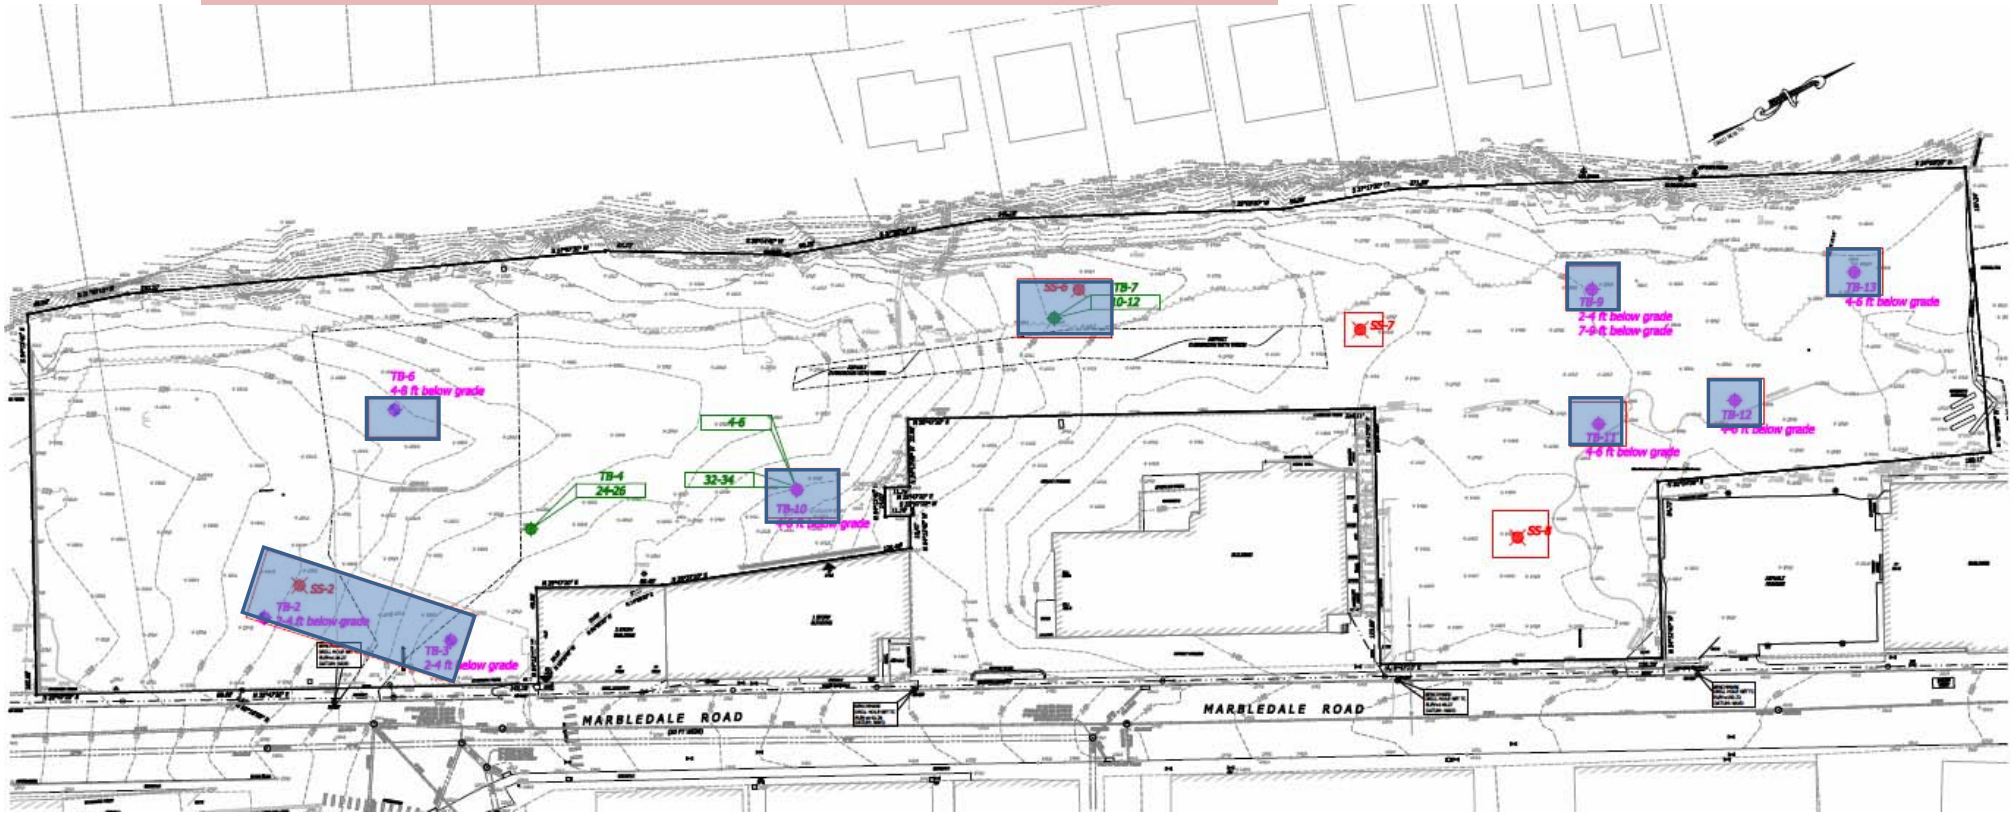
# Hotspot removal areas

(based on August 2016 Remedial Action Work Plan)

Area removed to depth of 4-ft or more
-

Surface soil removal

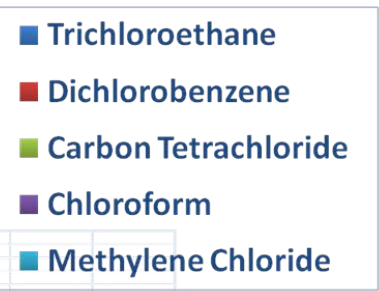
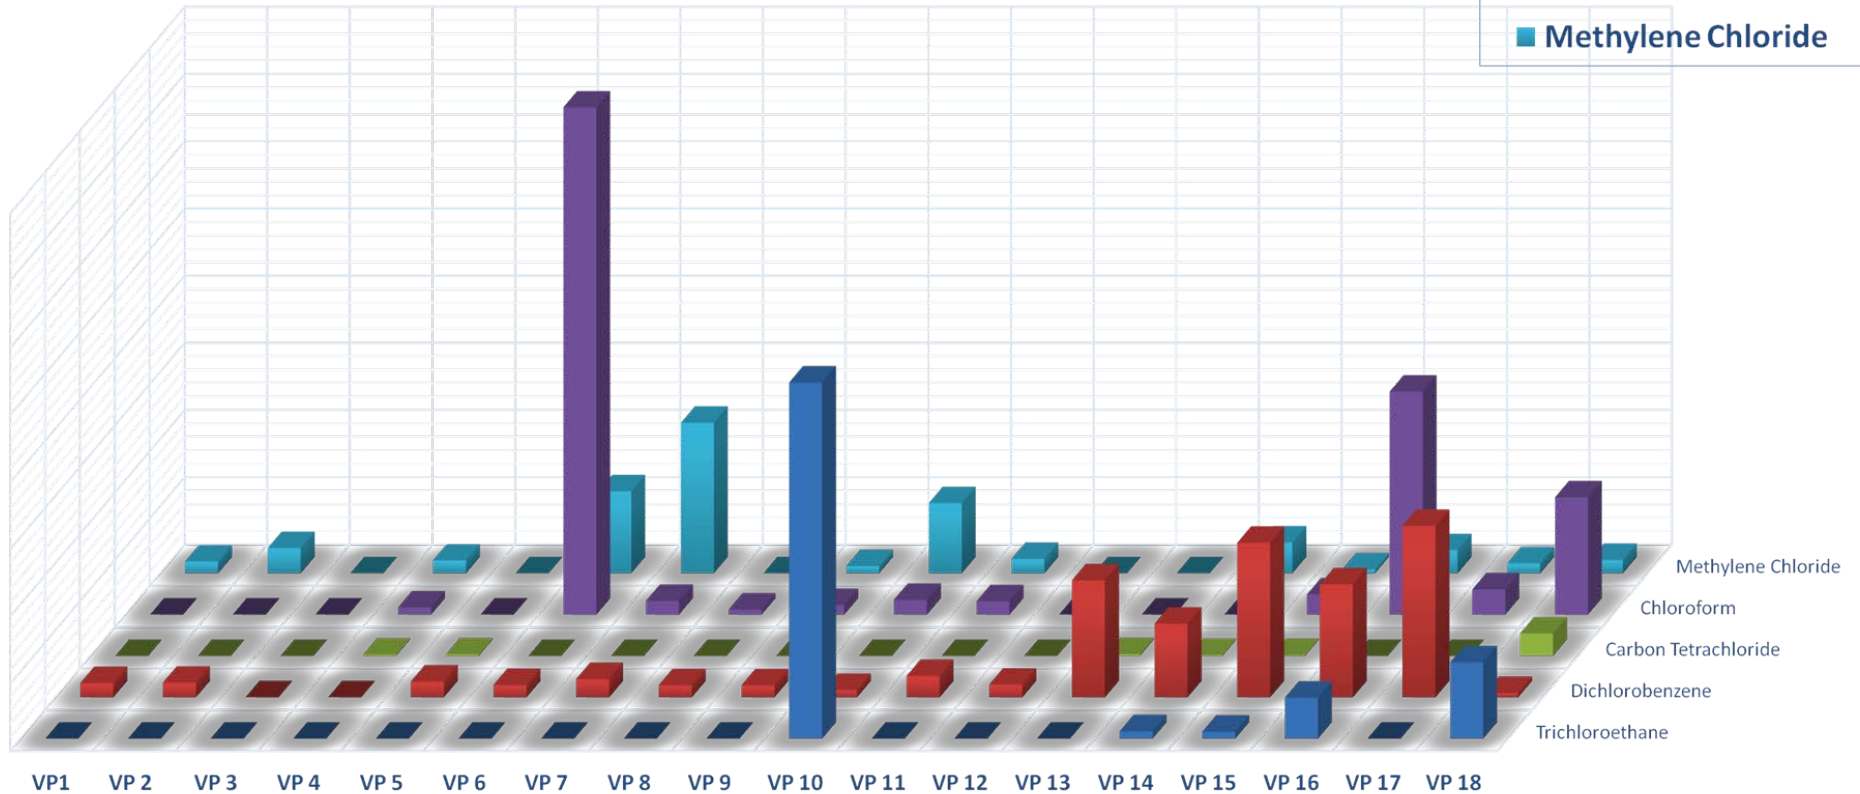
# Soil Vapors at Marbledale BCP Site: Chlorinated Organic Compounds, Group 2

Concentration ( $\mu\text{g}/\text{m}^3$ )

Sampling Points

Methylene Chloride  
Chloroform  
Carbon Tetrachloride  
Dichlorobenzene  
Trichloroethane

- Chloroform - exceeds USEPA cancer risk ( $37 \times 10^{-6}$ )
- Other compounds (Methylene chloride, trichloroethane, dichlorobenzene) are below all guideline values

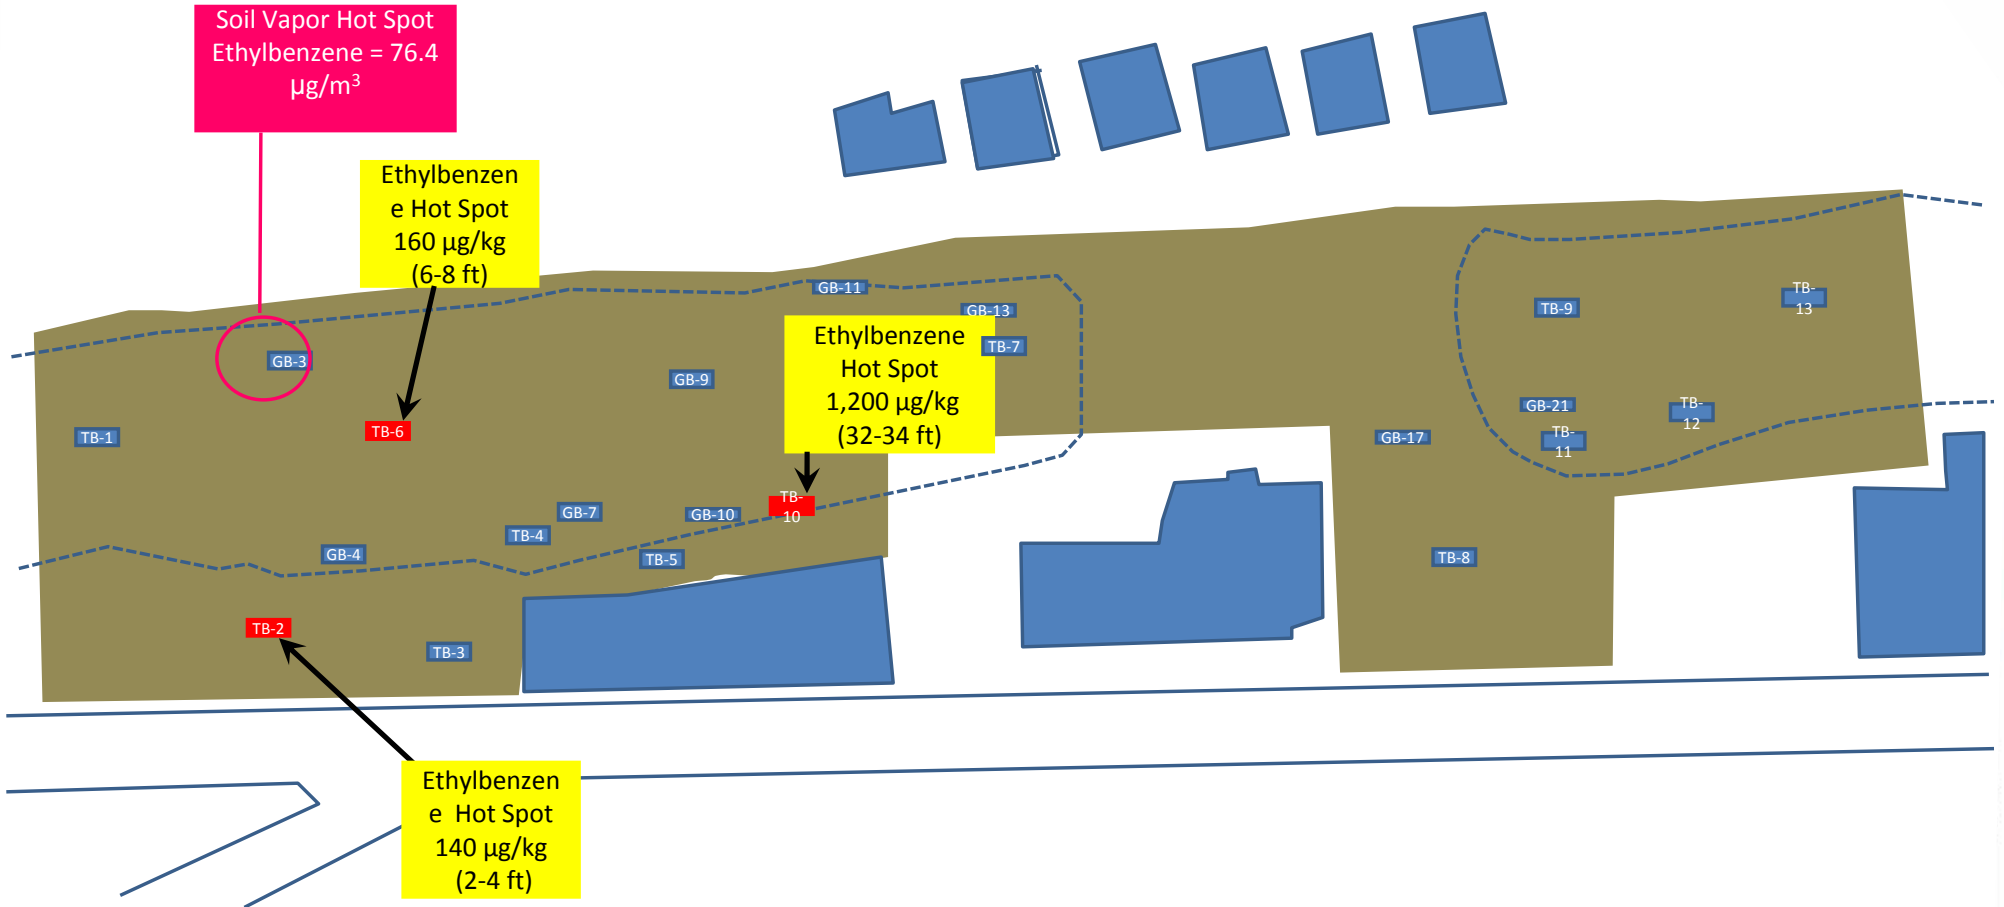
# Ethylbenzene Hot spots in Soil

- Key to symbols:
- Surface soil sample
  - Soil boring (2013)
  - Soil boring (2015)
  - Monitoring well
  - Soil vapor point
  - Soil vapor point

- General gasoline contamination throughout site
- Independent hot spots of
  - benzene
  - toluene
  - Xylene
- Signifies: separate sources of contamination—not petroleum

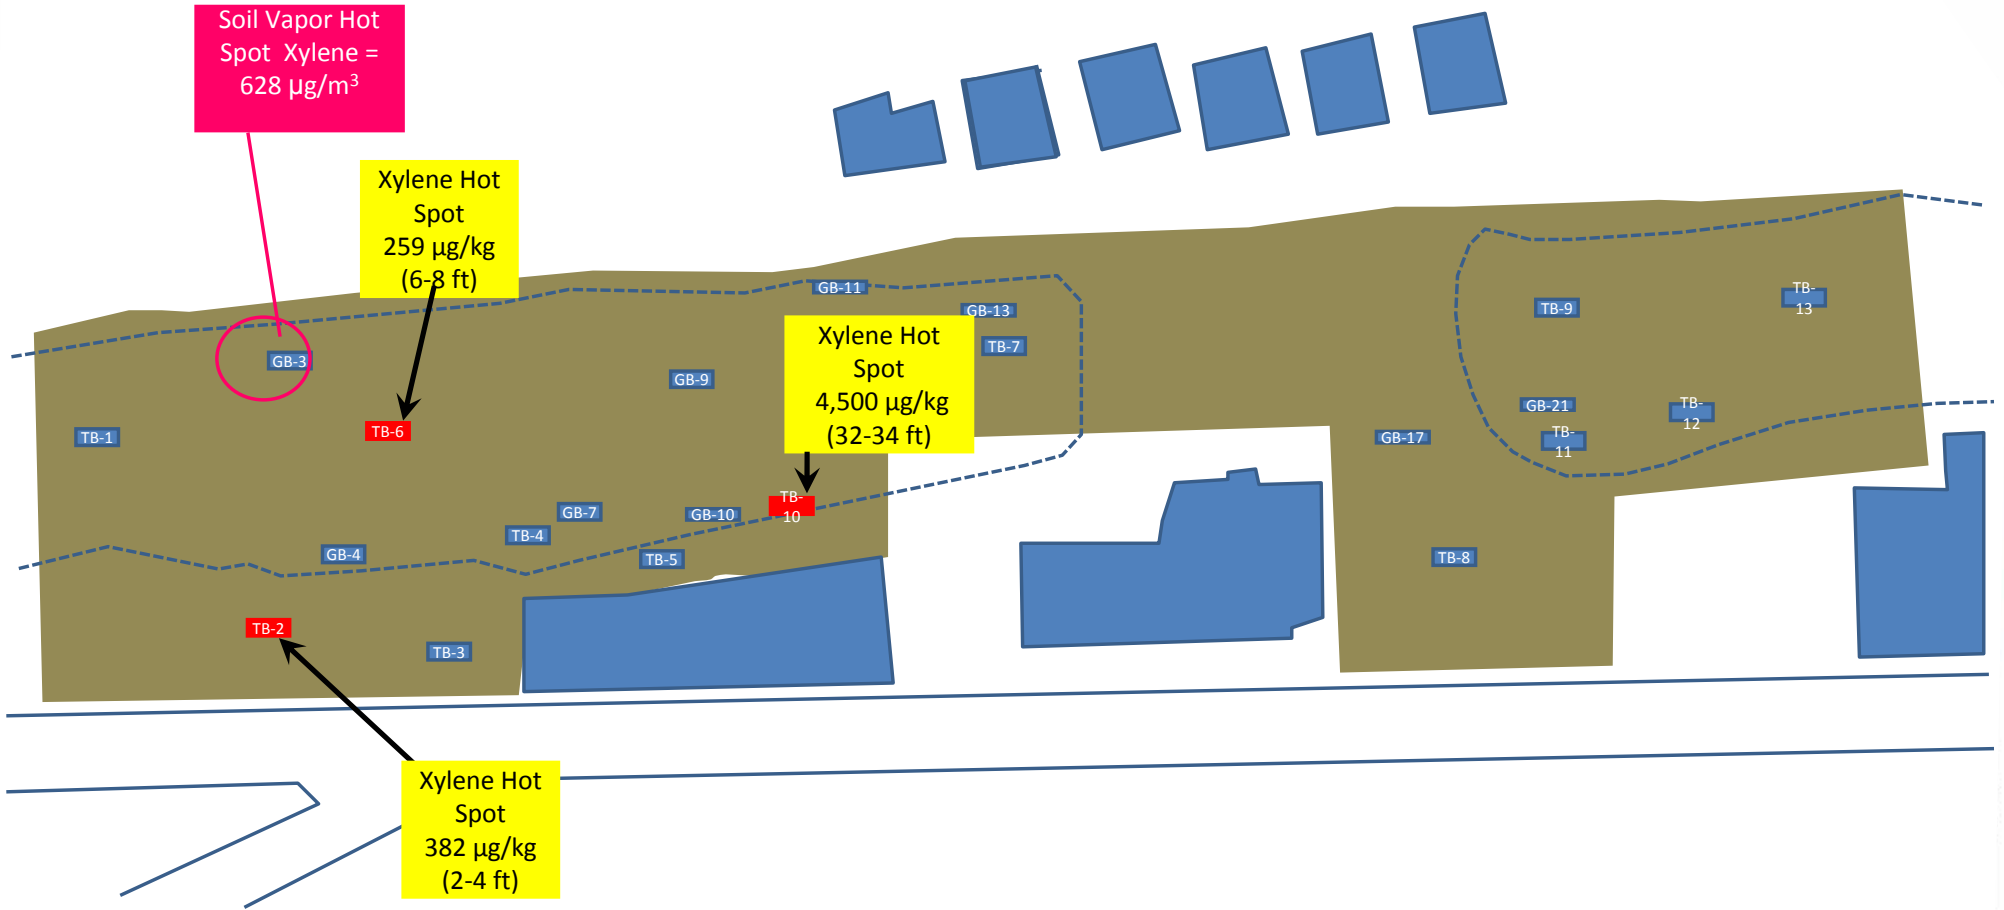
# Xylene Hot spots in Soil

- Key to symbols:
-

Adapted from HydroEnvironmental Solutions (2016) Remedial Investigation Report, Figure 3.  
 Note that locations of soil borings installed in 2013 are approximate.

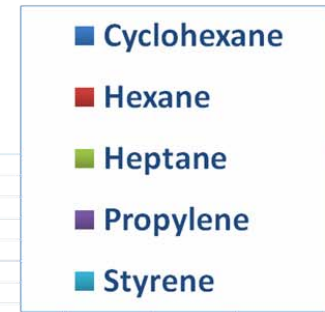
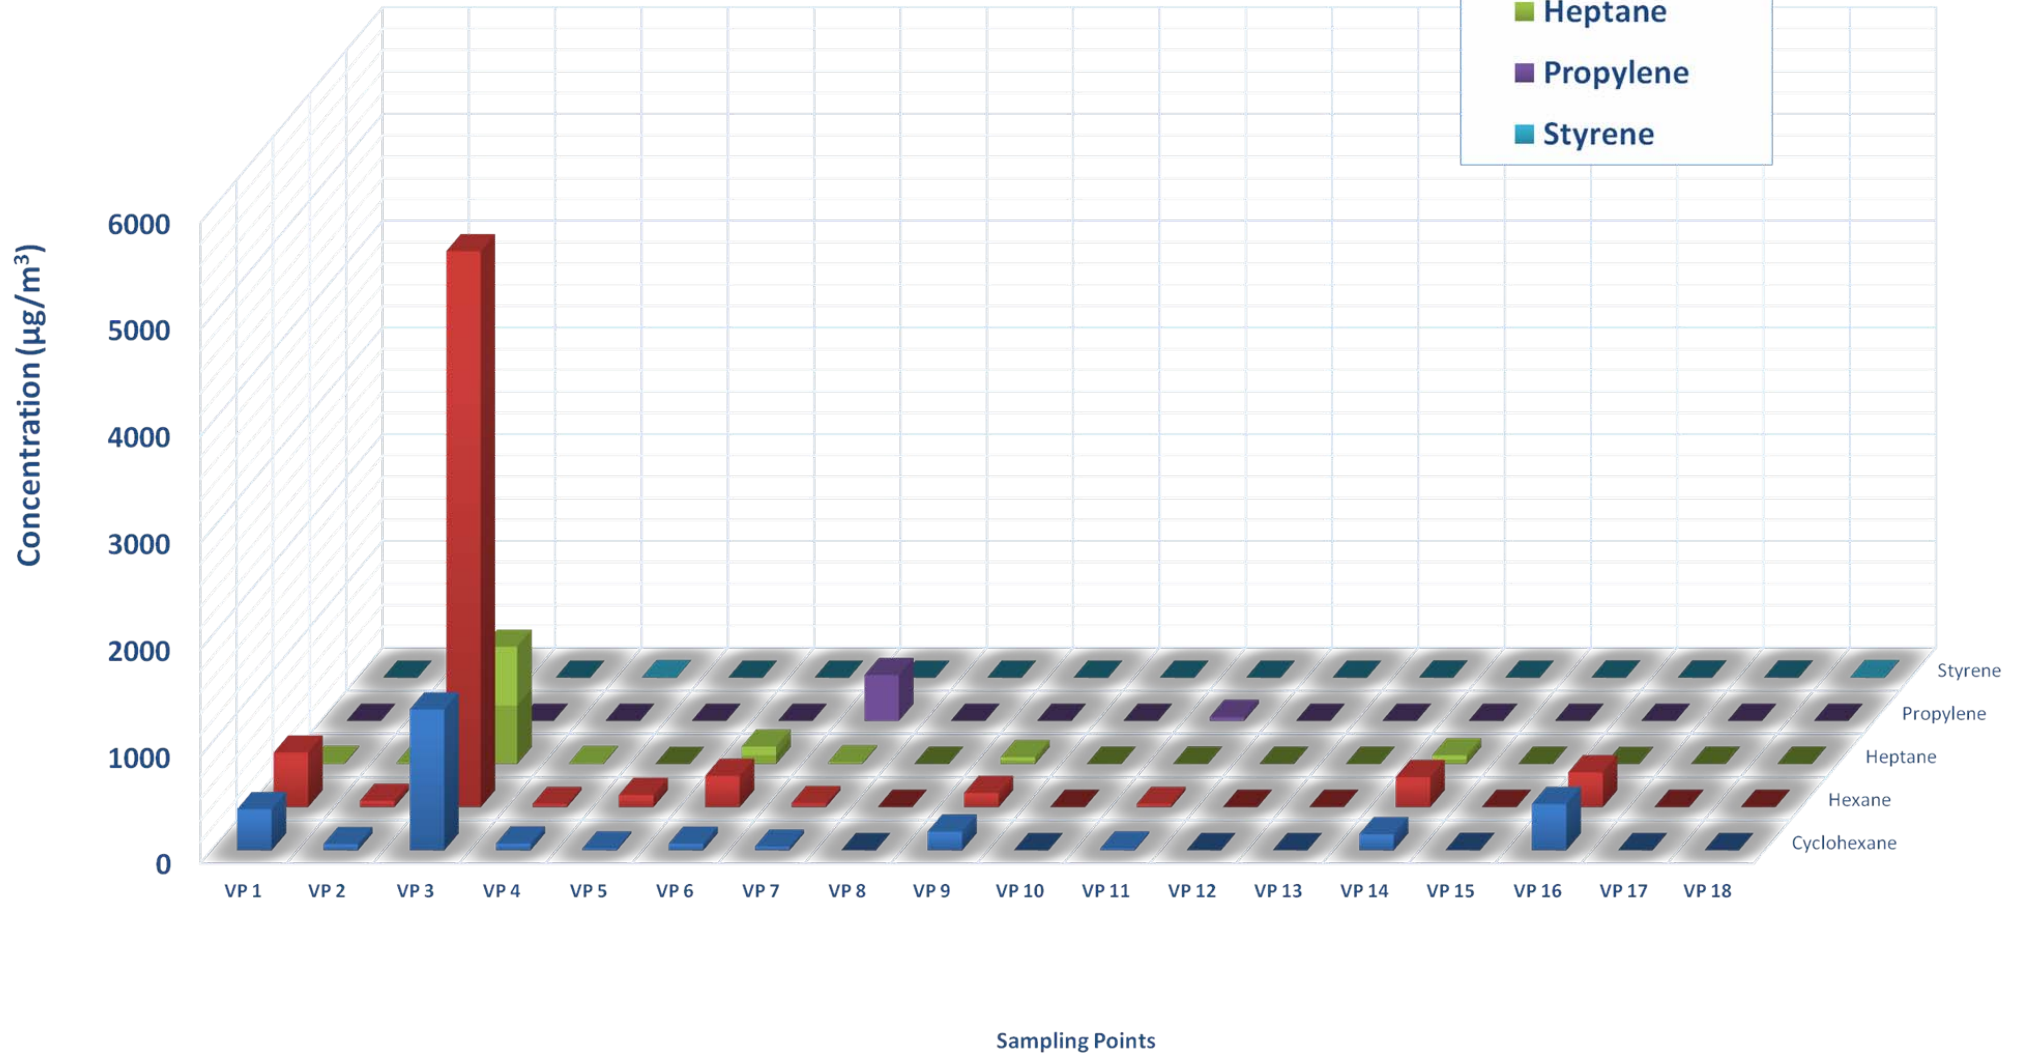
# Soil Vapors at Marbledale BCP Site: Other Hydrocarbons

Cyclohexane, Hexane, Heptane,  
Propylene, Styrene

- Higher concentrations compared to chlorinated compounds, BTEX, but also less toxic
- One clear hot spot at VP-3

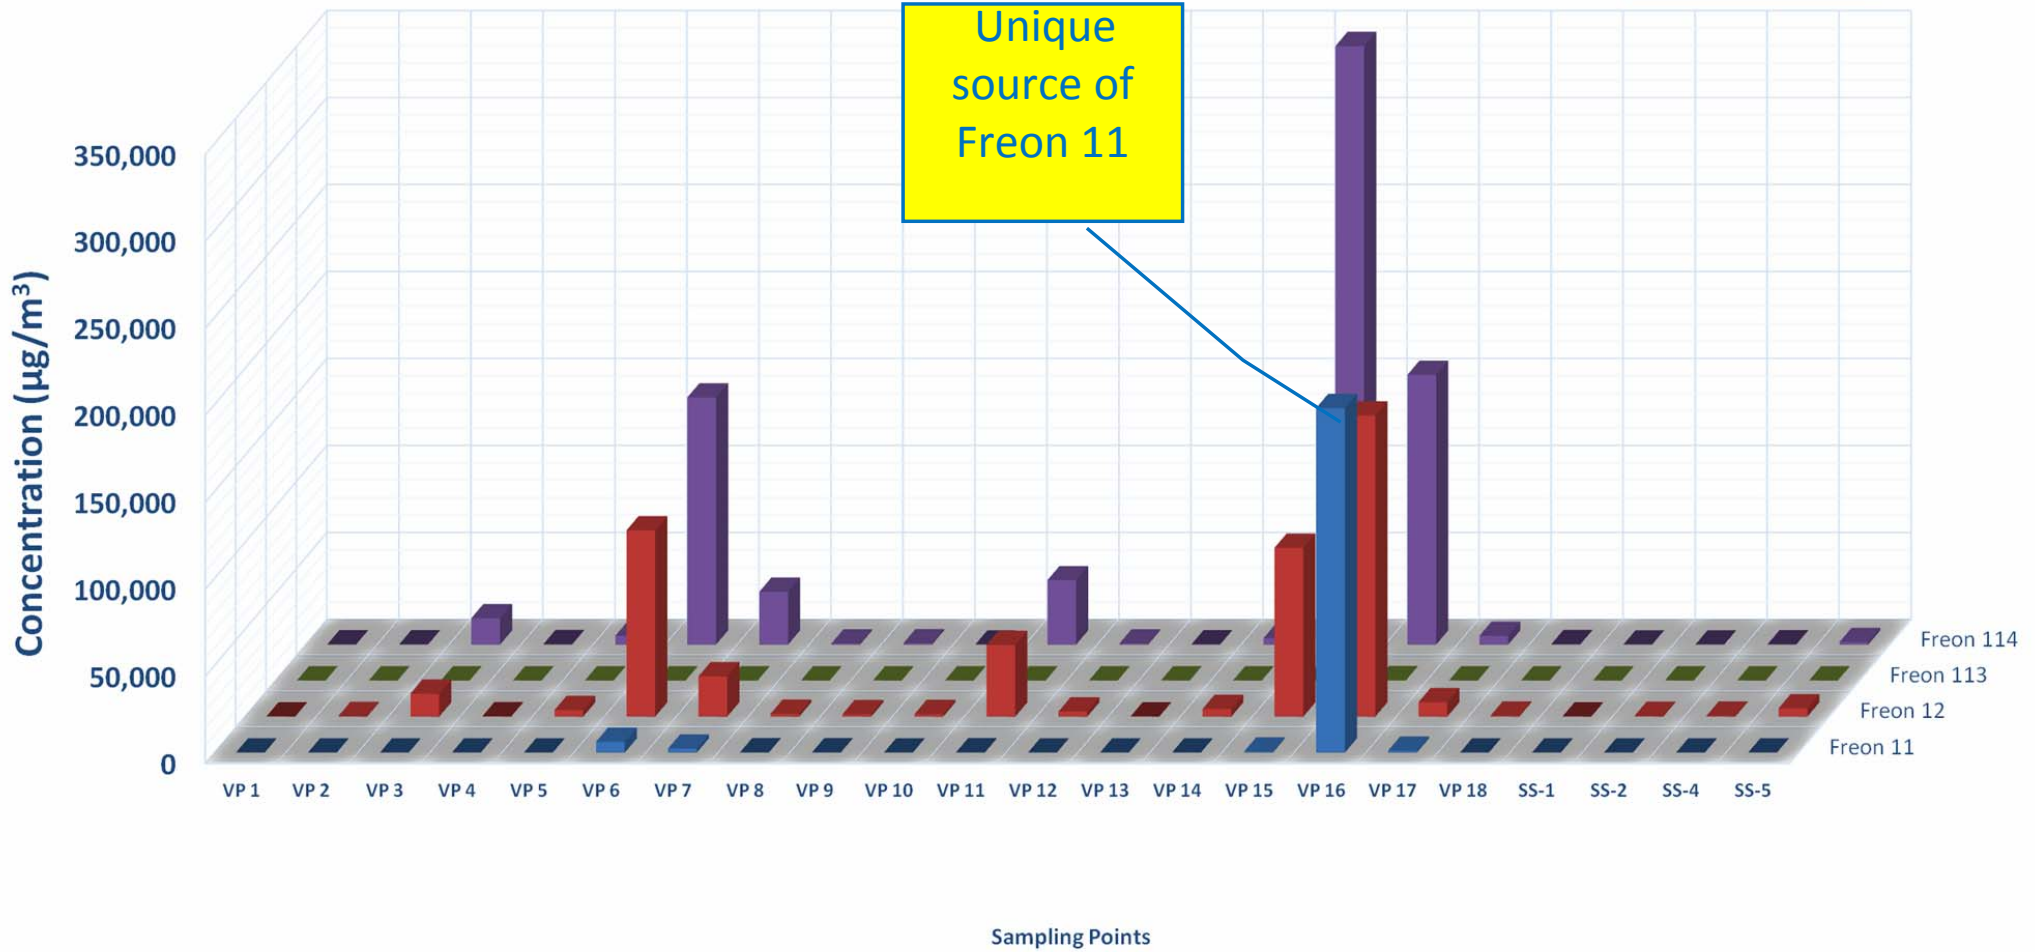
# Soil Vapors at Marbledale Dump Site

- Freon 11
- Freon 12
- Freon 113
- Freon 114

- Highest concentrations! Up to **520,000  $\mu\text{g}/\text{m}^3$**
- Likely leaking from tanks, AC/refrigeration equipment
- Source(s) are in central part of site, W of 125 Marbledale Rd.
